Vehicle Control Unit (VCU) for the HMMWV

Background of HMMWV Starting Problems

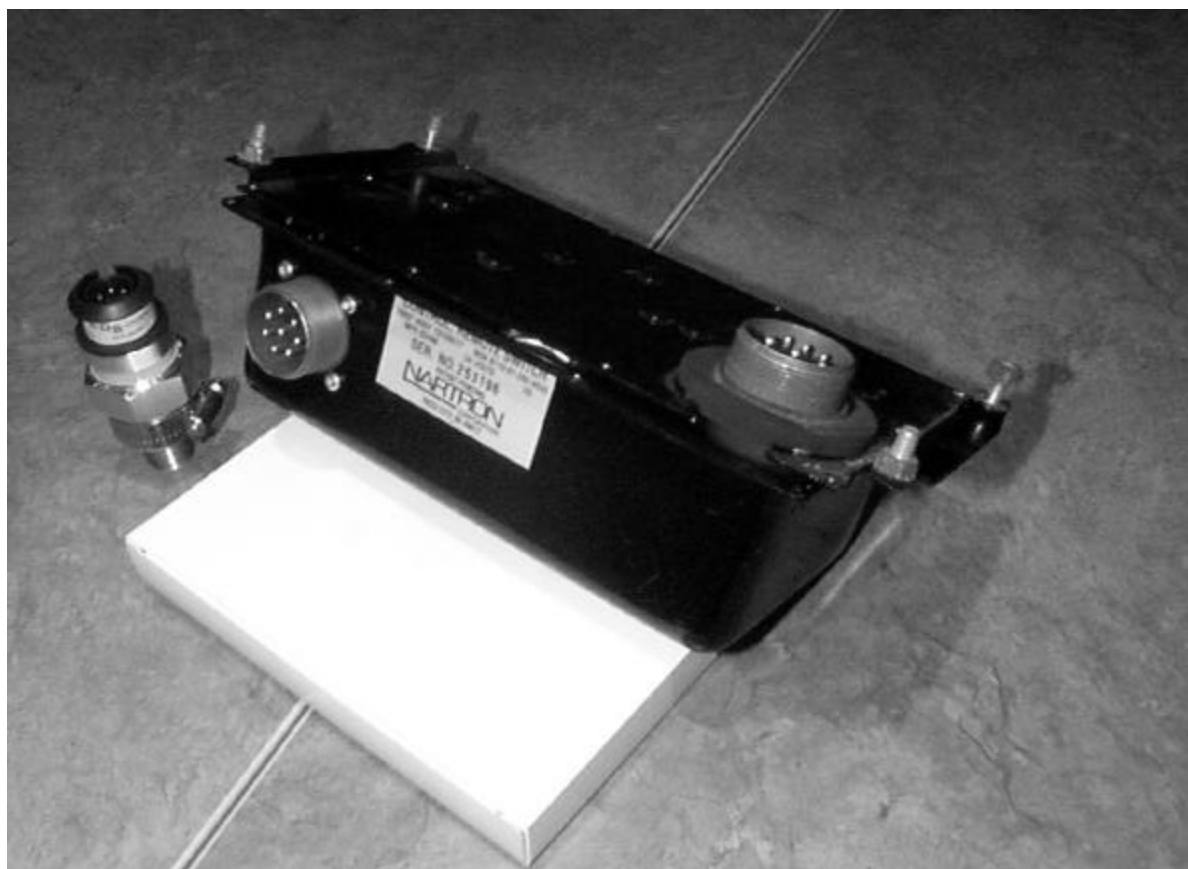
Obsolete PCB & GPC

- **Most Failed Item** in the Army's Inventory:
 - **25,000 PCBs Failed** Every Year (\$150/Box)
- **PCB Failures Caused:**
 - **480,000** Glow Plugs to Fail Every Year (\$4.50/Plug)
 - **72,000** Glow Plug Controllers (GPC) to be Replaced Every Year (\$45/Controller)

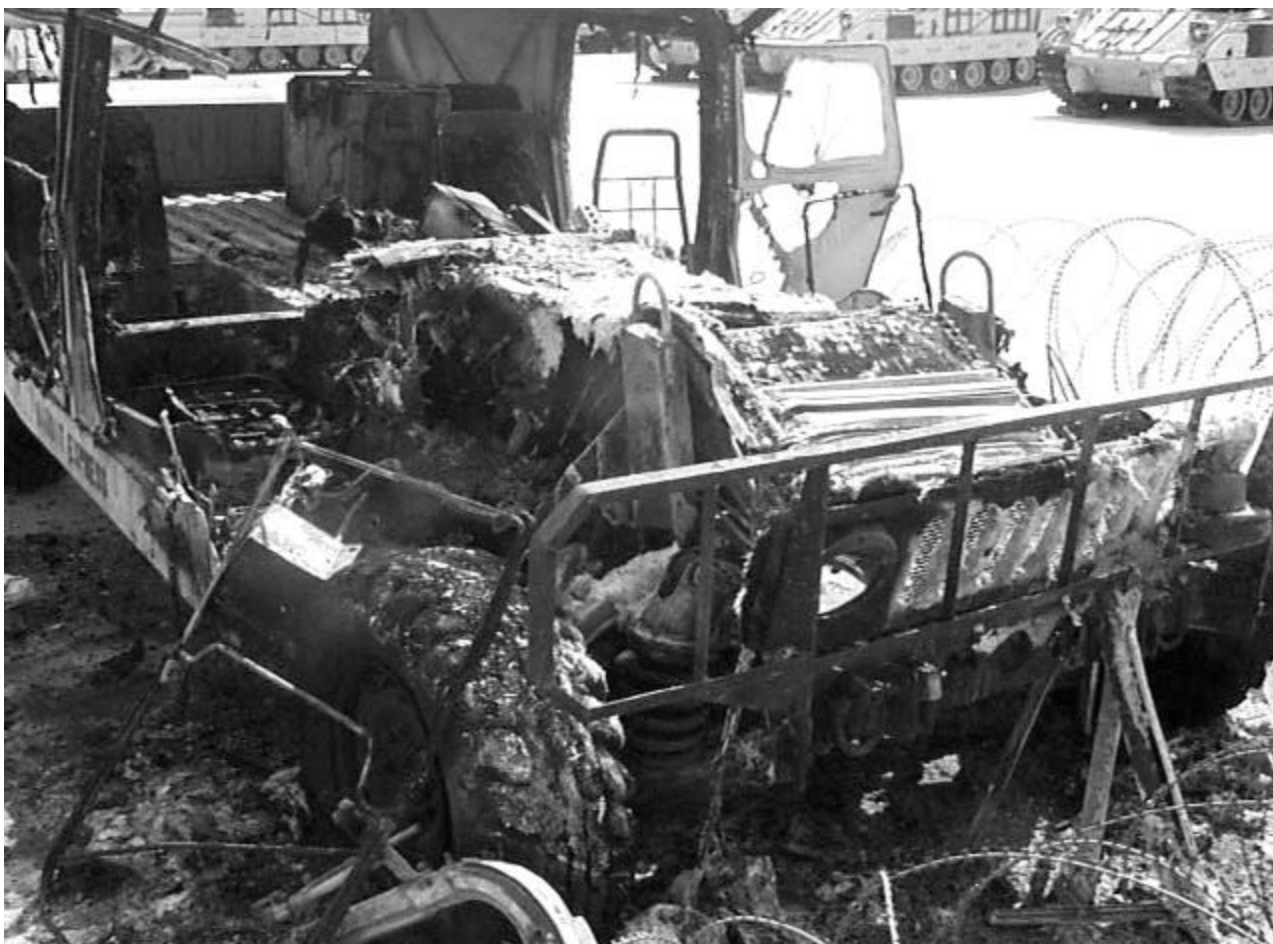
HMMWV Fire at Ft. Stewart, GA.

- **Some PCB Versions Not Properly Water-Sealed, Nor EMI-RFI Tested**
- **Relays NOT Military Rated – Per Manufacturer**
- **Results:**
 - **Relay Coils Burn out Much too Quickly**
 - **Relay Contacts Weld Shut – Causes Glow Plug Burn-out and Phantom Cranking Leading to Vehicle Fires**
